Shafi Knit Ltd.

Natun Para, Baipail (beside DEPZ-2), Ashulia, Savar, Dhaka
(23.945646N, 90.277794E)

12th May 2019

Structural Inspection Report

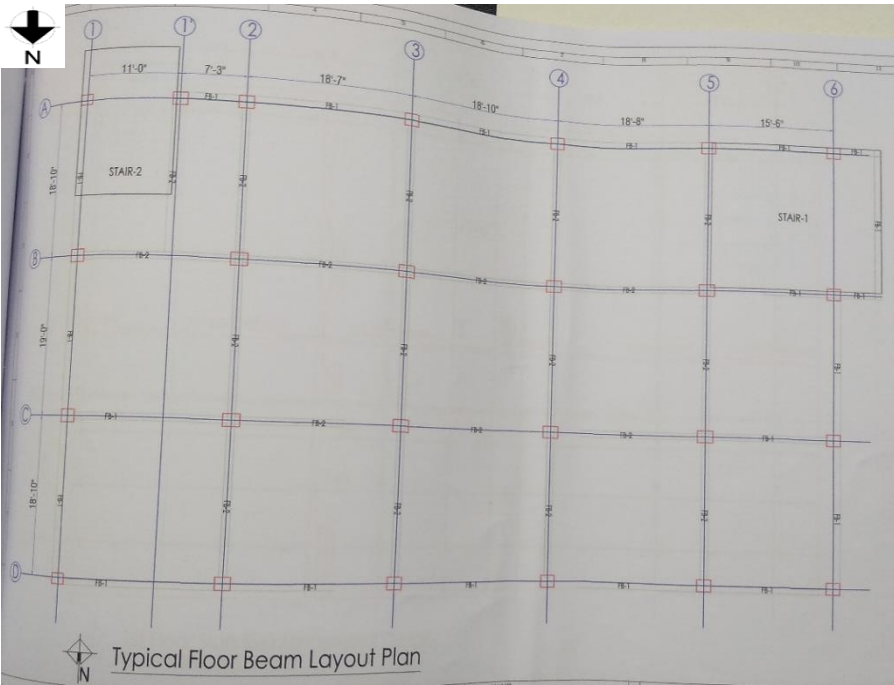
Typical floor beam layout

Cantilever beams were found only at 3rd floor roof. A Typical Floor Beam Layout Plan shows cantilever beams. In addition, beam down stand was measured 200 mm instead of 250 mm (as per provided as-built drawing) at 1st to 3rd floor beams.

- Building Engineer to survey the structure and prepare accurate as-built drawings.

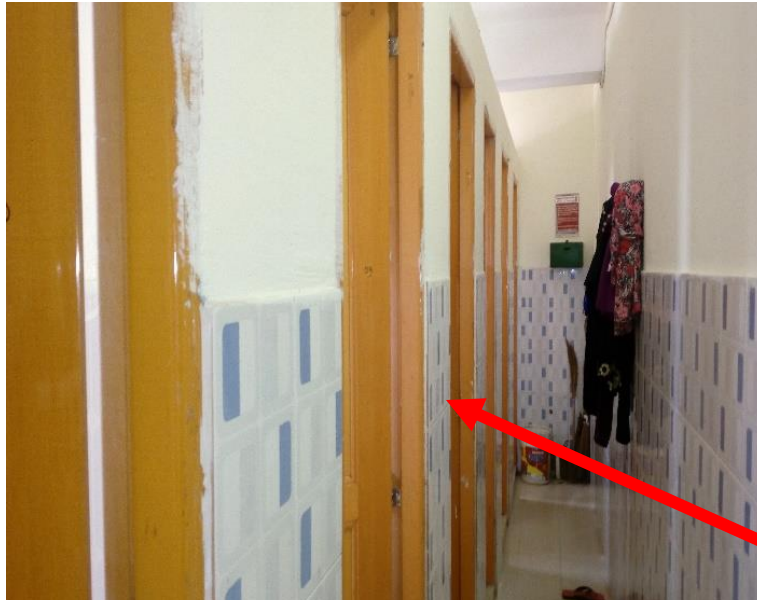
Toilet Zone

Number of toilets did not match with as-built drawings. Six nos. of female toilets were found on site where as-built drawing shows three nos.

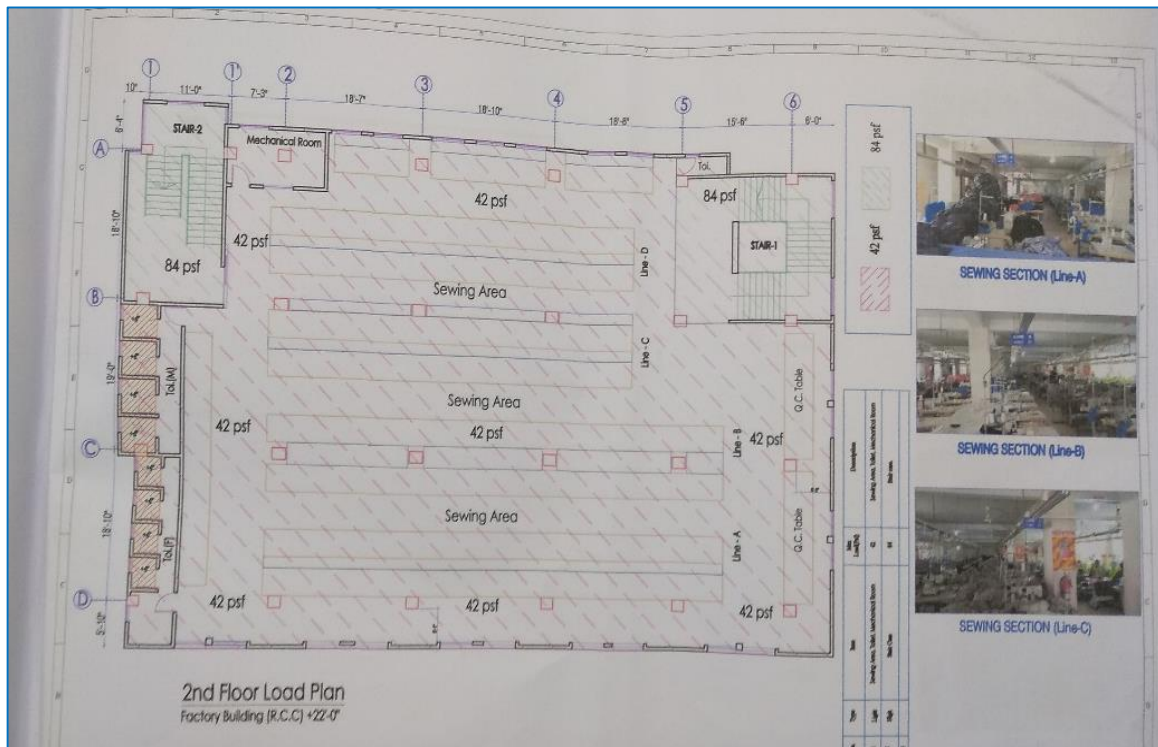
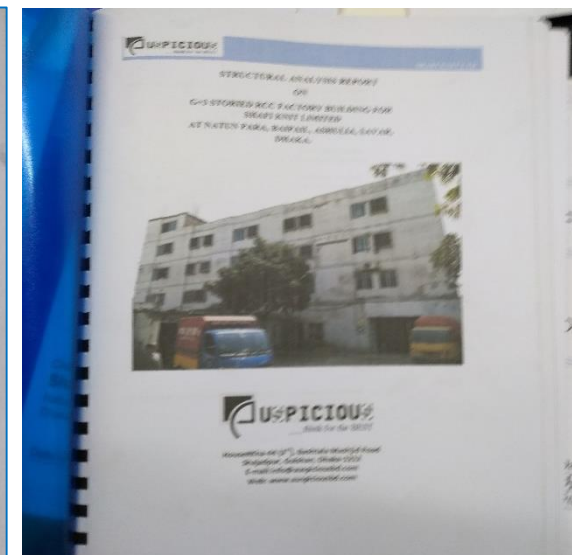
Design Report

The provided Load Plan shows 2 kPa loading. As the second phase of construction started in July 2015 and ended in March 2016 up to roof top shed the Load Plan must be in accordance with BNBC Standard.

Factory is required to revise the DEA including Load Plan as per actual onsite condition and submit to Accord.

- Design report required to be reviewed by ACCORD.
- Produce and actively manage a loading plan for all floor plates within the factory, considering floor, column and foundation capacity as per BNBC provision.

- Complete remedial works arising from design report.
- Continue to implement load plan.

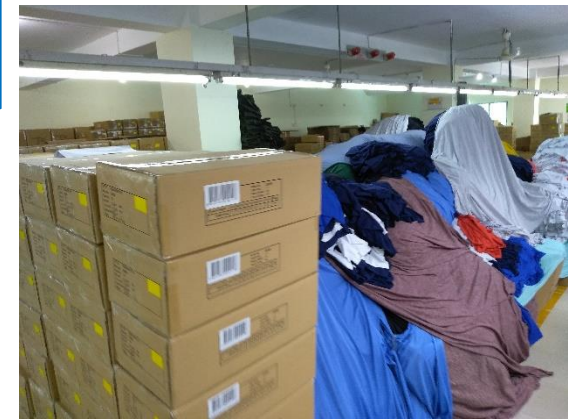
Floor loading

During inspection no over loading was found. FoS calculation for internal & external columns were found satisfactory considering 3 KPa allowable floor live loading for all buildings.

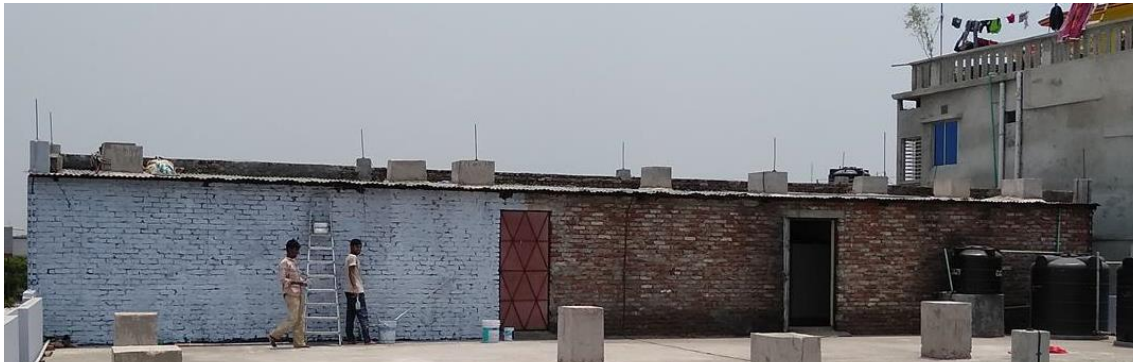
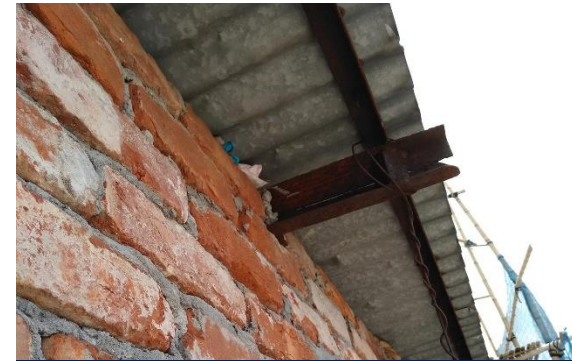
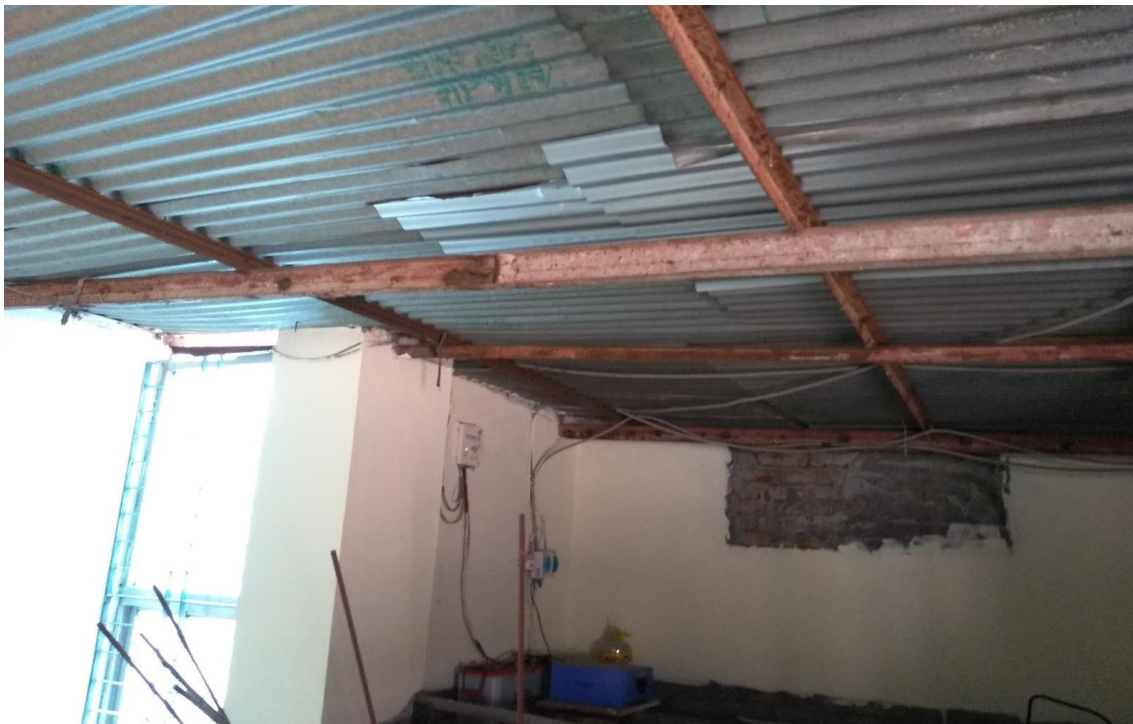
Roof Shed

Non-engineered connection

Light weight roof supported on brick wall

Apparent non-engineered shed was found at roof level. Light weight roof structure supported on 125 mm brick wall. The connections appeared to be non-engineered. No documentation was available onsite.

- Prepare “as constructed” drawings which reflect the actual site dimensions with complete structural information.
- Building engineer to check the capacity of the light weight roof structure against lateral loading.

- Carry out remedial works resulting from engineering assessment if necessary.

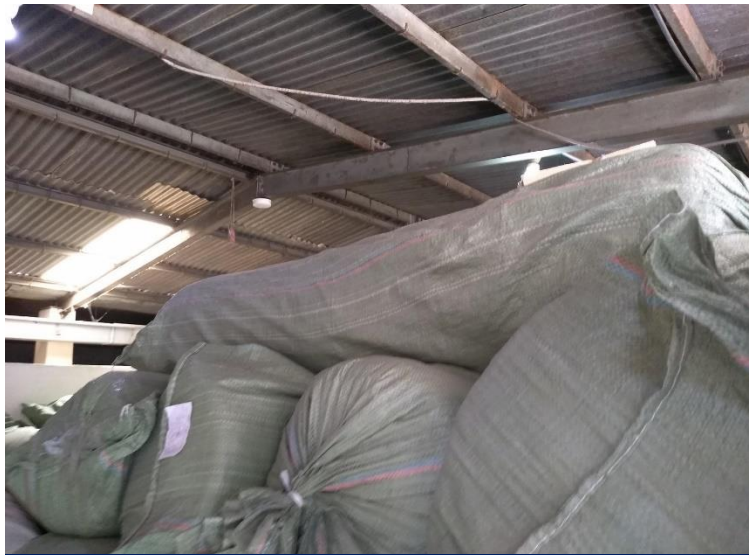
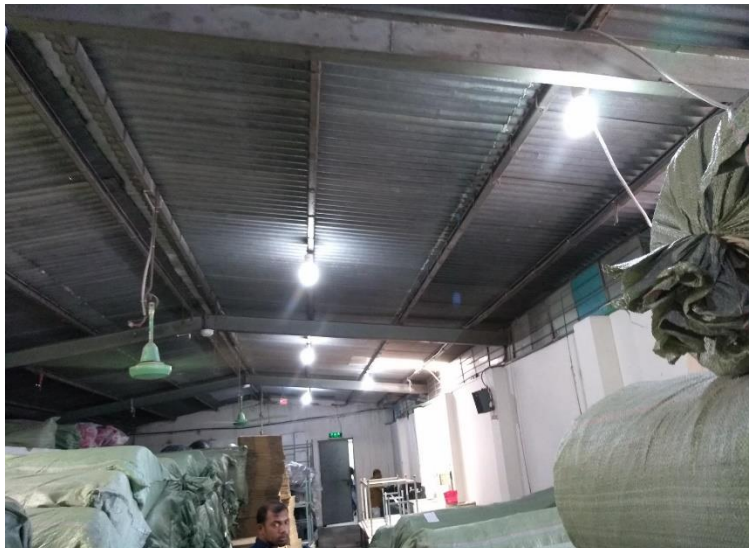
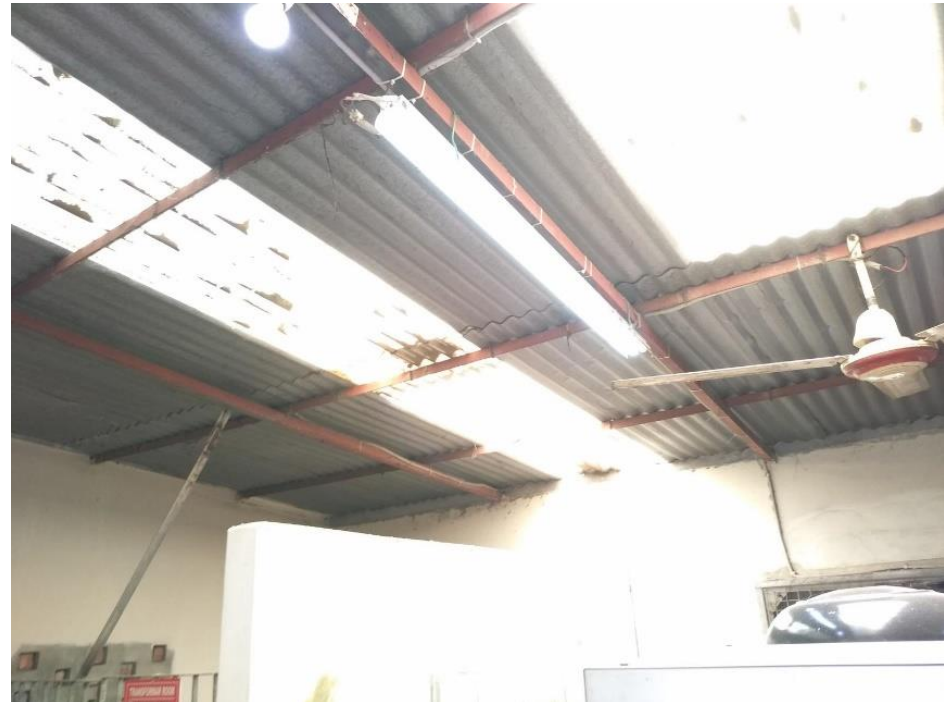
No documents were available for shed 1 & 2.
Building engineer is required to prepare “as constructed” drawings that includes connection details which reflect the actual site dimensions with complete structural information.

- Prepare “as constructed” drawings which reflect the actual site dimensions with complete structural information.

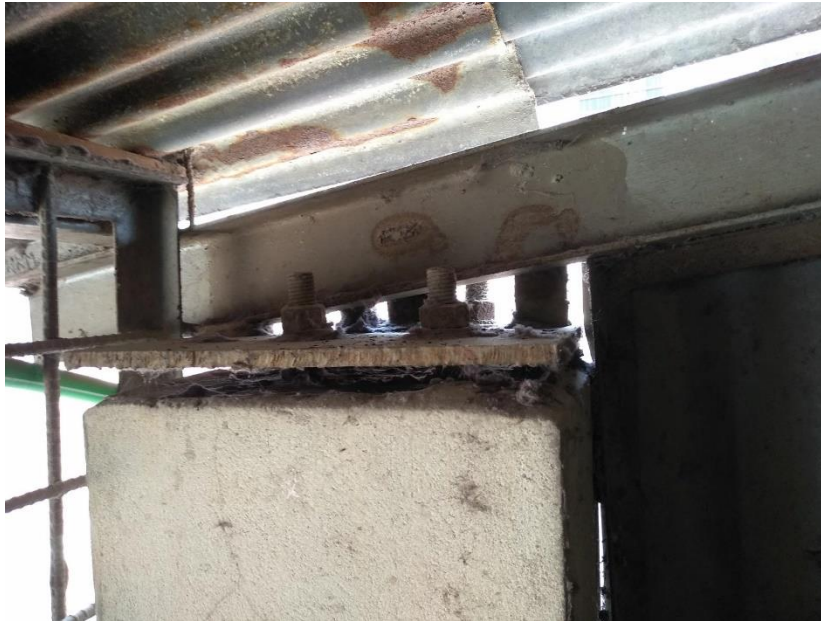
Significant gap observed between steel baseplate and RCC column.

- Check the adequacy of the connections.
- Carry out suitable remedial works as per suggestion of factory engineer.

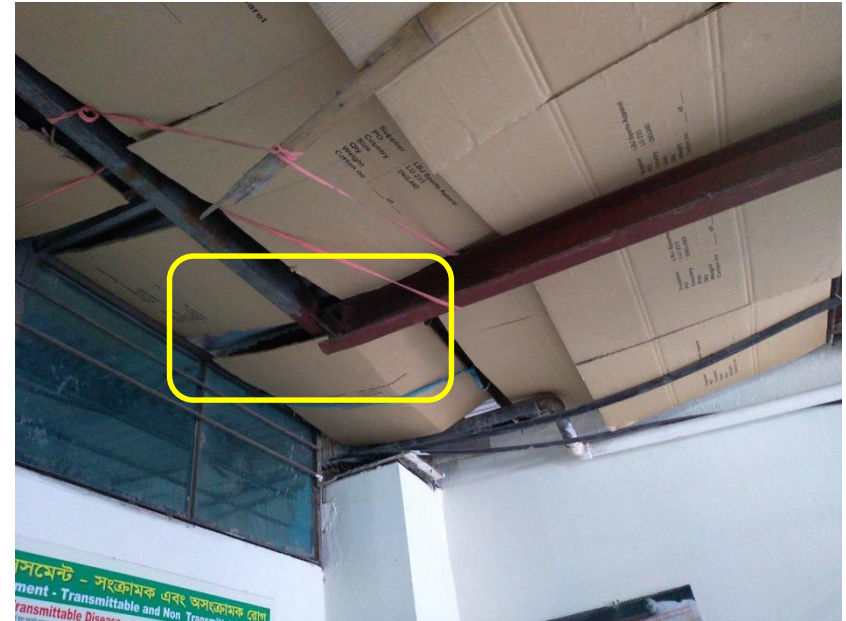
Poor/non-engineered connection was found at extension of shed-1 (doctor's room)
