FIRE SAFETY INSPECTION REPORT

SHAFI KNIT LTD

Date: 12 May, 2019

Fire Safety Inspection Report

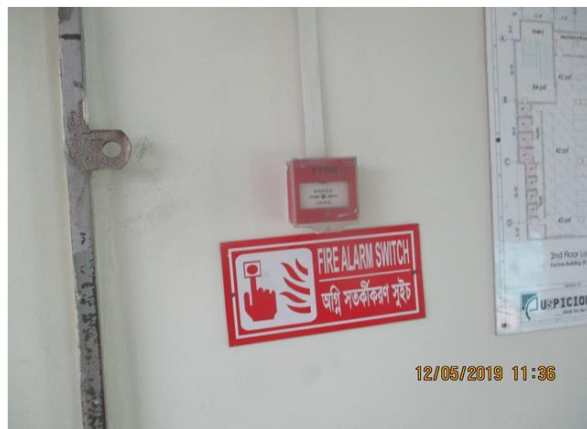
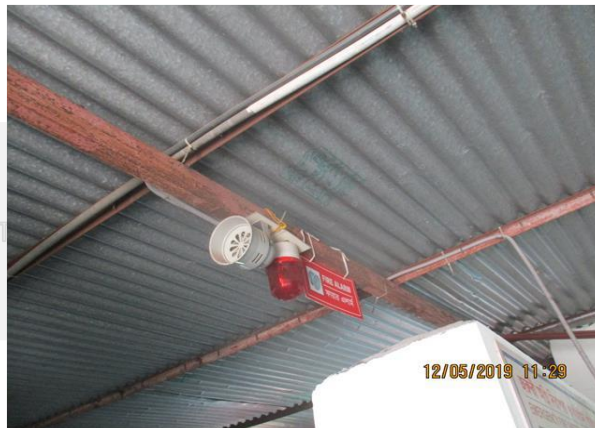
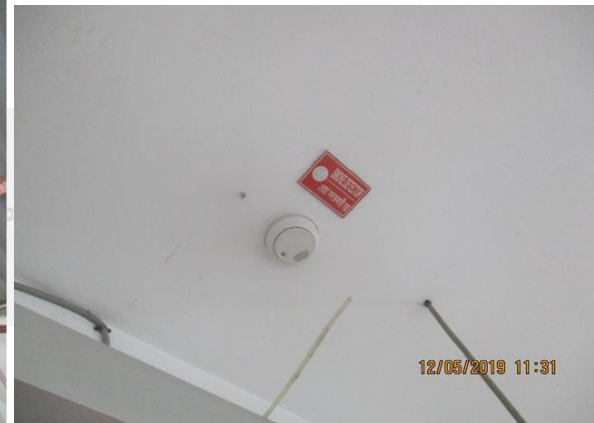
Current System Overview: Single station smoke alarms were located in various places throughout the factory. Very few smoke alarms were provided in the factory, and they were not installed correctly. These smoke alarms were not tied into the fire alarm system. In the event they detected smoke, they would provide a local alert sound. No records or assertions of regular testing or maintenance of the fire detection system were provided.

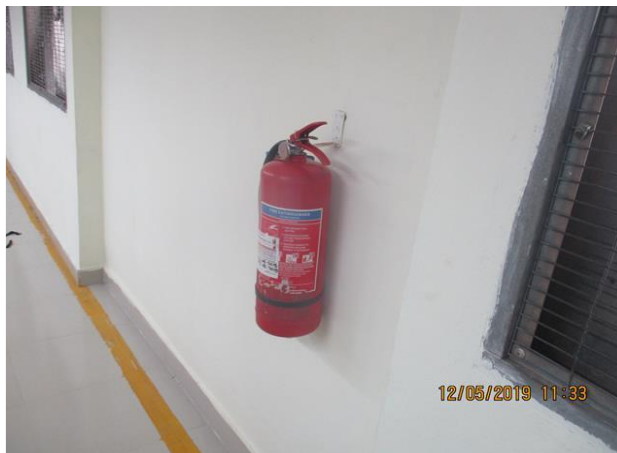
Current System Overview: Portable fire extinguishers, consisting of a mix of CO2 and ABC extinguishers were provided throughout the building. Inspection tags show recent and up-to-date inspections. Records or assertions of regular testing or maintenance of the portable fire extinguishers were provided.

Types Provided	ABC, CO2	
Adequate Number/Spacing	No	
ITM Per NFPA 10	No

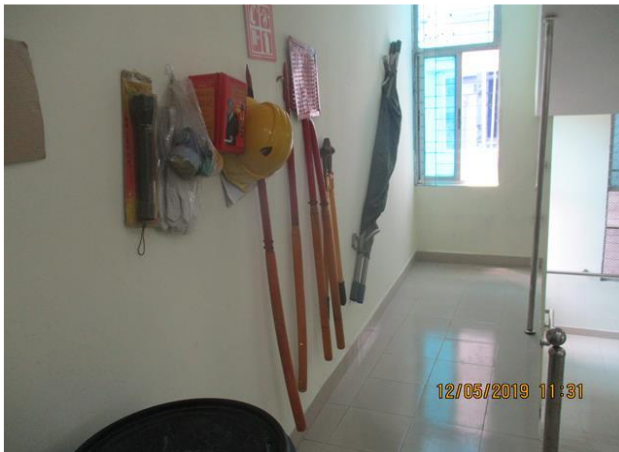
Types Provided	Extinguishers, buckets, escape hoods, bolt/lock cutters, shovels, stretchers and personal protection equipment.	
Location of Equipment	Inside the floor and near the exit stair.

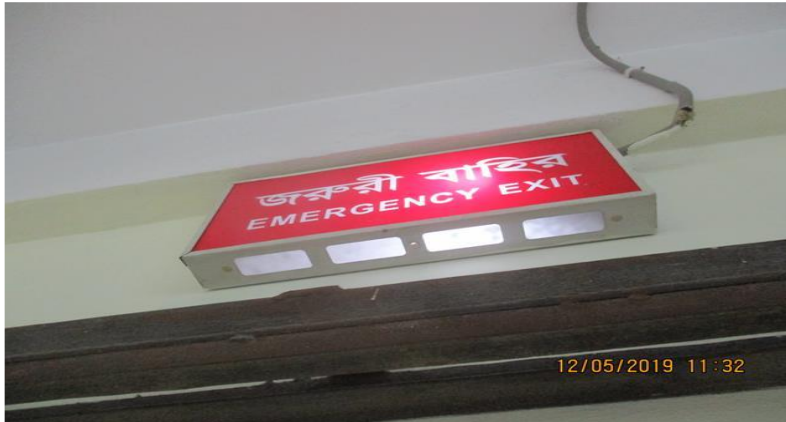
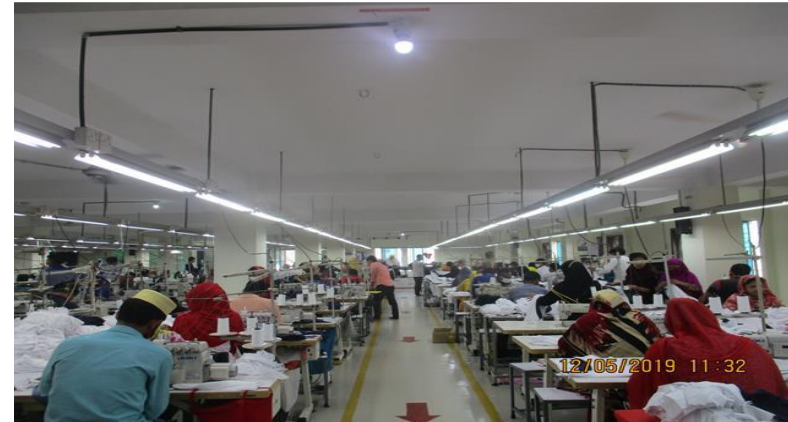
Overview: Emergency lights & exit signs have not been sufficiently provided in the production floor and above exits. There were few self battery emergency light located inside the production floor but it was not sufficient . They are keeping records or assertions of regular testing or maintenance of the emergency lighting system & exit signage units as per standard.

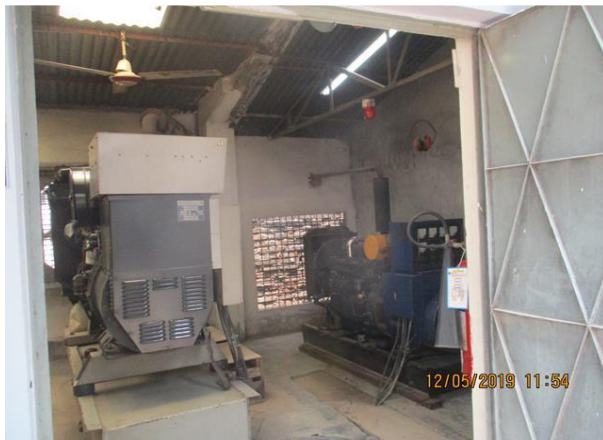
Overview: There are total two generators set up in shed-2.

Location(s)	Shed-2	
Fire Rated Separation	No	With transformer
Generator Area Free of Additional Fuels	Yes

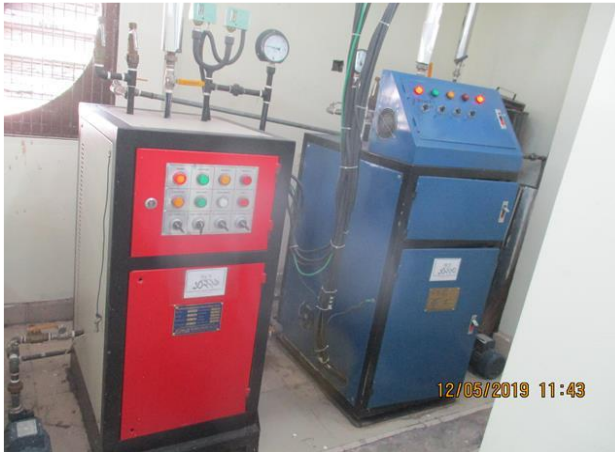
Location(s)	1st floor	
Fire Rated Separation (Accord 3.4.2.1.5)	No

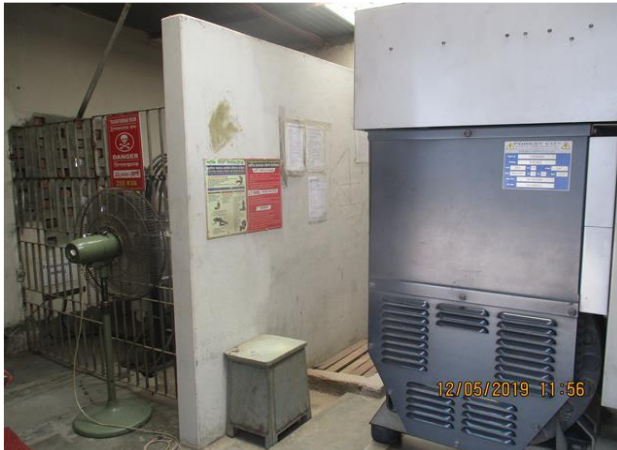
Location(s)	Shed-2	
Fire Rated Separation (Accord 3.4.2.1.5)	No	Not separated with generators.

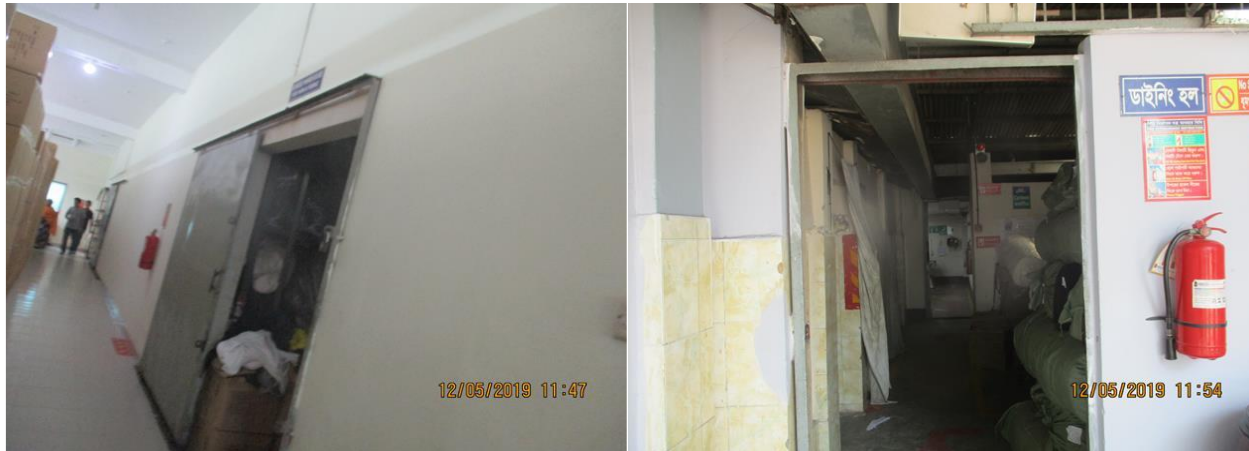
Fire Rated Separation (Accord 3.4.2.1.5)	No	
Open to Factory Floors?	Yes	
Open to Exit Discharge?	Yes

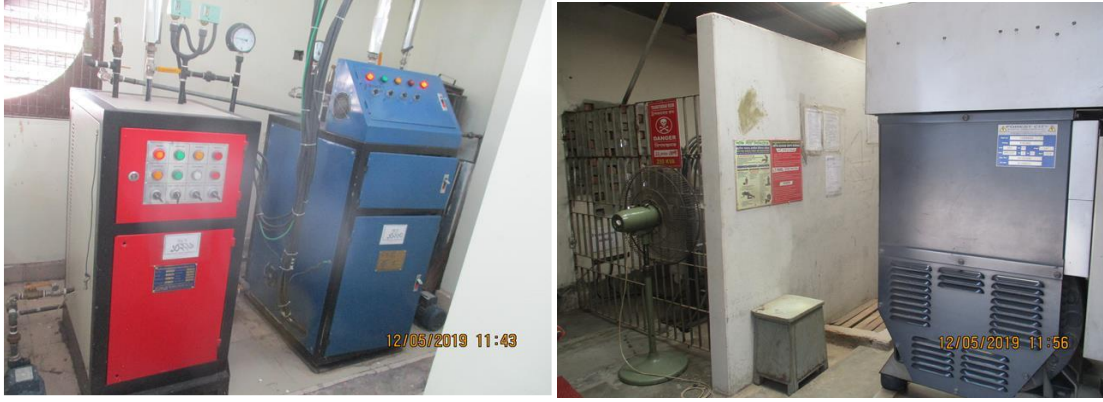
Sl No.	Category	Findings	Required Action	Remediation Time Frame
1	Fire Rated Construction	The boiler, generator and substation rooms are not fire separated with fire rated construction barrier or assemblies.	<p>Separate the boiler and compressor rooms by a minimum 1-hr fire-rated construction with 0.75-hr fire rated opening protective assemblies like fire rated door.</p> <p>Similarly separate generator and substation room by a minimum 2-hr fire rated construction with 1.5-hr fire rated opening protective assemblies like fire rated door. Provide proper ventilation and consult a qualified engineer for overall solution.</p> <p>When located to the exterior of a building by at least 3m (10 ft.) distance from surroundings then fire rated construction barrier is not mandatory.</p>	Within 3 months

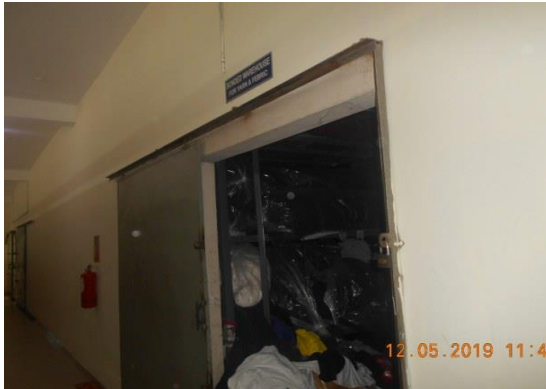
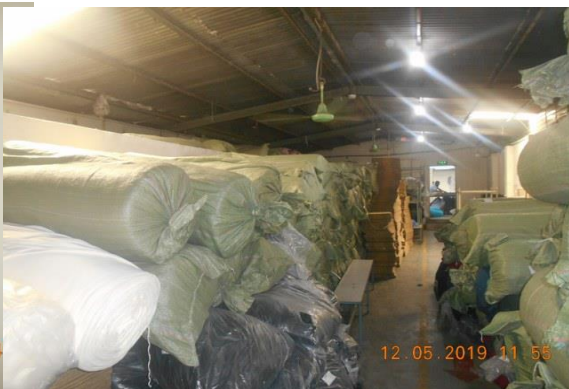
2	Fire Rated Construction	<p>Rooms used for combustible storage are not separated by fire rated construction.</p> <p>Location: Fabric Store, Wastage Store (Shed 1); Ground floor Bonded Warehouses</p>	<p>Separate the dedicated storage rooms by minimum 1-hr fire-rated construction. Provide 0.75 hr. fire rated door and seal all penetrations and openings by 1 hr. fire rated fire rated barrier construction.</p>	Within 3 months
<div style="display: flex; justify-content: space-around;">

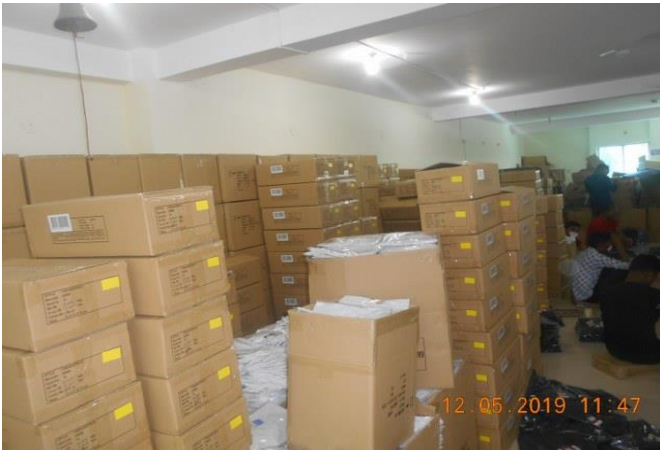
3	Fire Rated Construction	<p>Areas used for combustible storage open to the factory are not separated by fire rated construction.</p> <p>Location: 1st floor</p>	<p>Separate the dedicated storage rooms by minimum 1-hr fire-rated construction. Provide 0.75 hr. fire rated door and seal all penetrations and openings by 1 hr. fire rated fire rated barrier construction.</p> <p>Where separate storage rooms are not feasible, provide defined storage areas and limit the storage arrangement as follows: - Maximum height of 2.45m (8ft.) and maximum area of 23m² (250 ft²) - If sprinkler protected: maximum height of 3.66m (12ft.) and maximum area of 93m² (305ft²). Separate areas of unenclosed combustible storage by a minimum clear distance of 3m (10ft.).</p>	Within 3 months

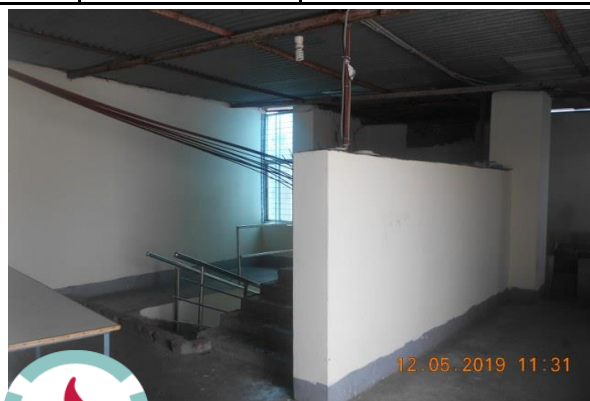
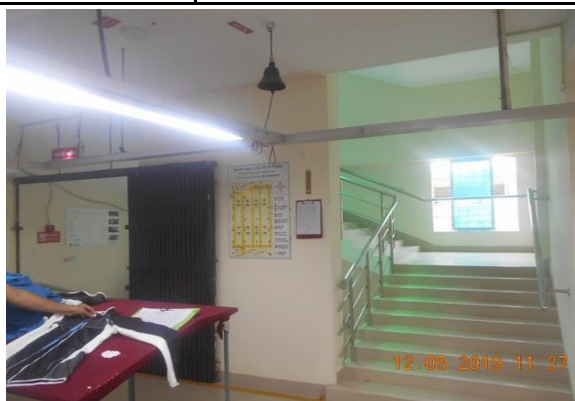
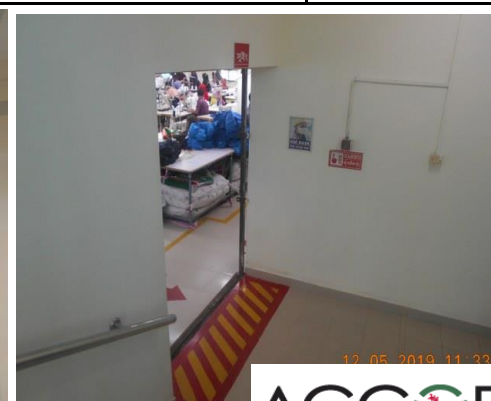
4	Fire Rated Construction	<p>The exit stairs are not separated from work areas and other spaces on each floor by fire rated construction. [Front Stair, Top floor (Rear Stair): Not enclosed, Unprotected openings]</p>	<p>The exit stair enclosure shall be provided with a minimum 1-hr fire resistance rating for buildings with 3 or fewer stories and a minimum of 2- hr. fire resistance rating for buildings 4 or more stories. Provide 0.75 hr. fire rated door and seal all penetrations and openings by 1 hr. fire rated fire rated barrier construction for building with 3 or fewer stories. Provide 1.5 hr. fire rated door and seal all penetrations and openings by 2 hr. fire rated fire rated barrier construction for building with 4 or more stories.</p> <p>Provide a fire-resistive rated assembly between the exterior exit stairs and the building up to 10 ft. beyond the end of the stair to achieve the required separation. The rated assembly shall be approved and/or designed by a qualified fire protection engineer.</p> <p>Ensure that the fire doors are self-closing and positive latching and that they are provided with fire exit (panic) hardware where serving production floors. If fire doors are required to be held open for functional reasons, provide automatic closing devices tied to the fire alarm system.</p>	Within 3 months

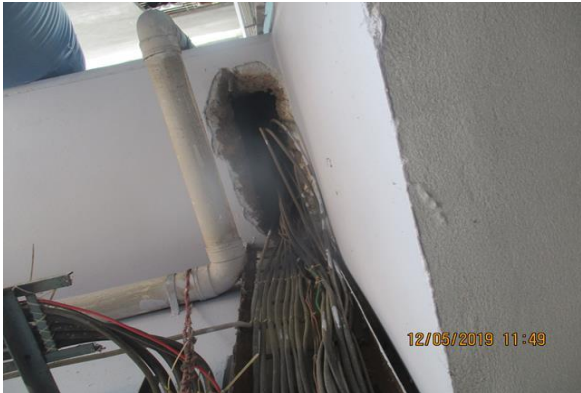
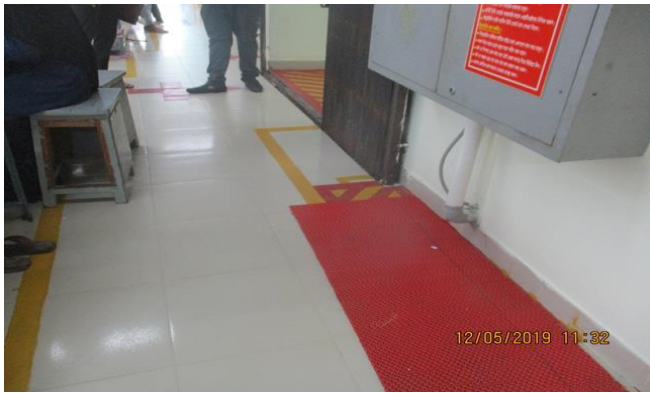
5	Fire Rated Construction	<p>Unsealed penetrations and openings are located in the fire-rated floor/ceiling assemblies.</p> <p>Location: Electrical riser on every floor.</p>	<p>Seal all penetrations and openings in floor/ceiling assemblies to maintain the fire separation.</p>	Within 1 months
<div style="display: flex; justify-content: space-around;">

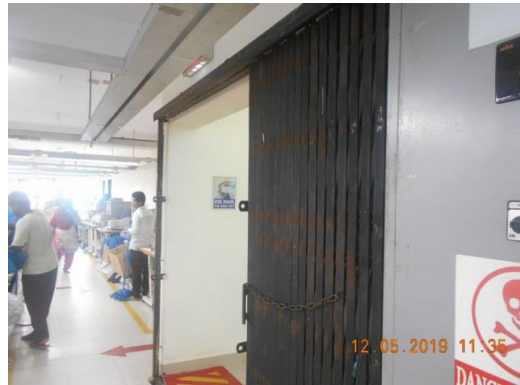
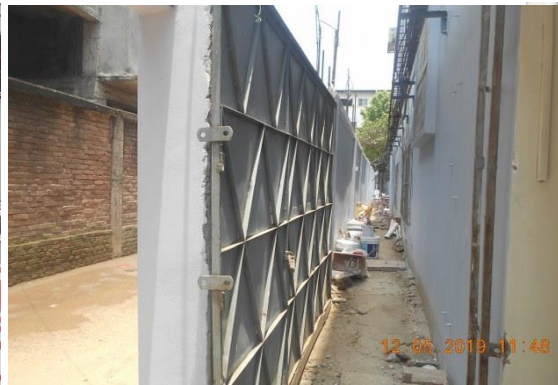
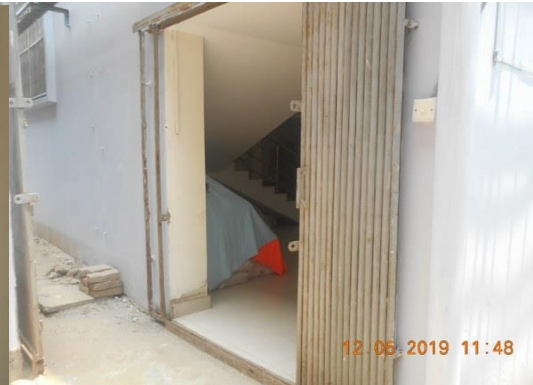
</div>				
6	Egress	<p>Collapsible gates/sliding gates are provided at building exits.</p> <p>Location: Exit stairs, Building exits</p>	<p>Replace all collapsible/sliding/shutter type doors & gates by the side-hinged swinging type doors.</p> <p>If locks are required for security reasons, utilize special door locking features complying with NFPA 101.</p>	Immediate

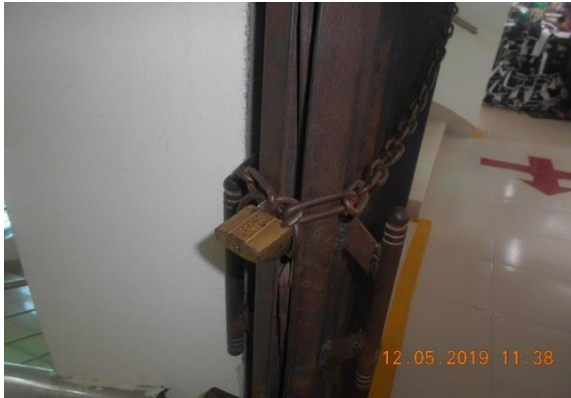
7	Egress	Egress doors and gates with locking features are provided at building exits, exit stairs, along egress routes and exit discharge on all floors. All doors and gates were open and unlocked during inspection.	<ol style="list-style-type: none"> 1. Remove all non compliant locking features from egress doors. 2. If locks are required for security reasons, utilize special door locking features complying with NFPA 101. 3. Doors may be locked where the latch and lock are disengaged with one motion where the occupant load does not exceed 49 persons. 4. Doors may be provided with locking hardware from the ingress side provided that a panic bar is installed on any door with an occupant load exceeding 49 persons. 	Immediate
---	--------	---	---	-----------

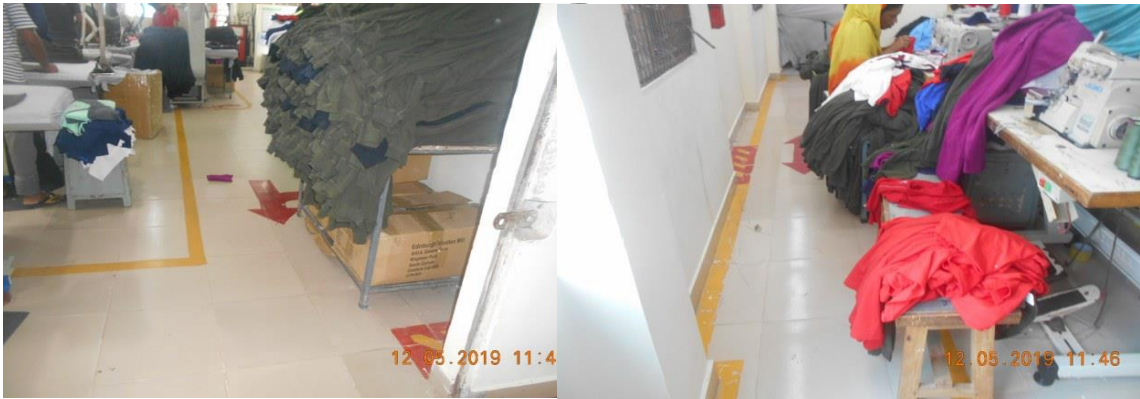
8	Egress	The width of egress aisles is less than 36 inch. Location: 1st & 2nd floor	Provide minimum unobstructed aisle width of 36-inch.	Within 3 months

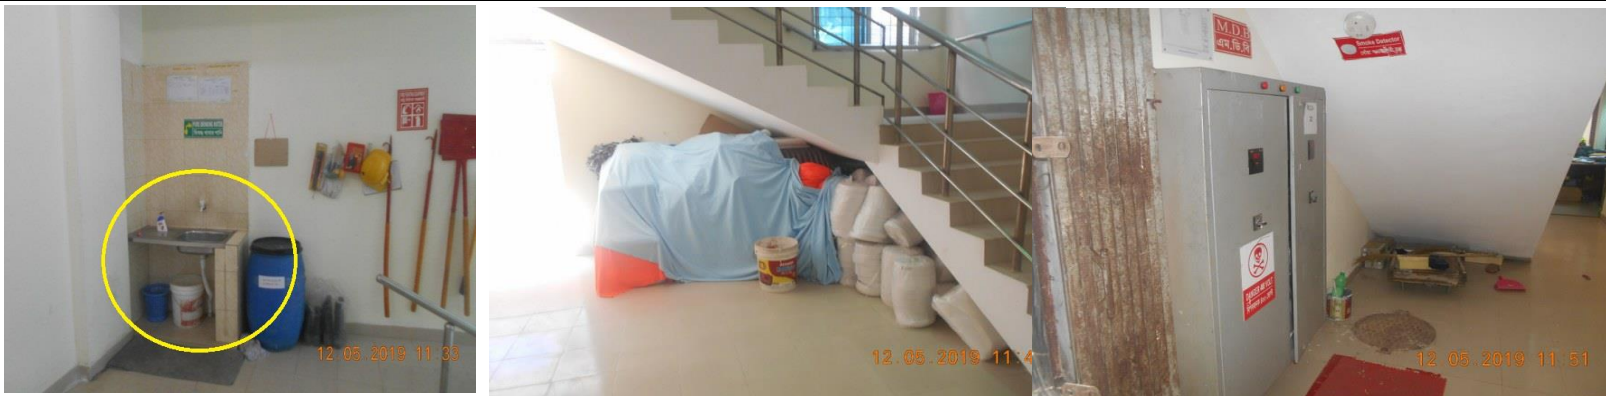
9	Egress	Storage/service equipment/electrical panel was located in the exit stair and egress path on every floors.	Remove all storage and other appliances from exit stairs and egress paths.	Immediate

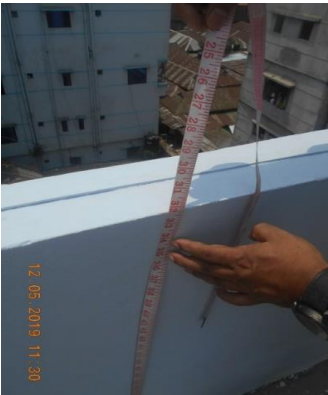
10	Egress	Parapets or guards are provided in occupied roof which is less than 1067mm (42 inch.).	Provide parapets or guards with a minimum height of 1067mm (42 inch.)..	Within 3 months

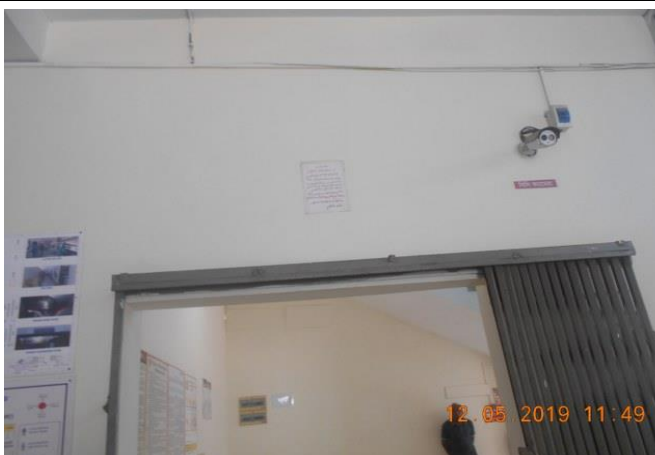
12	Egress Lighting	Based on the number and location of emergency lights observed, adequate illumination levels are not anticipated along egress routes and at exit stairs on all floors.	Test the emergency lighting system on each floor and provide additional emergency fixtures to supply adequate illumination along the means of egress. Provide a minimum illumination of 10 lux at the floor level within exit stairs and along exit discharge paths and a minimum 2.5 lux along exit access aisles.	Within 3 months
13	Egress Lighting	Exit sign was missing at an exit door at ground floor.	Lighted exit signs shall be placed at entrance to an exit. Additional exit signs shall be placed throughout the facility anywhere the continuation of the egress is not obvious. Lighted exit signs shall be provided with either battery backup or uninterruptable power supply systems and shall be continuously illuminated.	Within 1 month

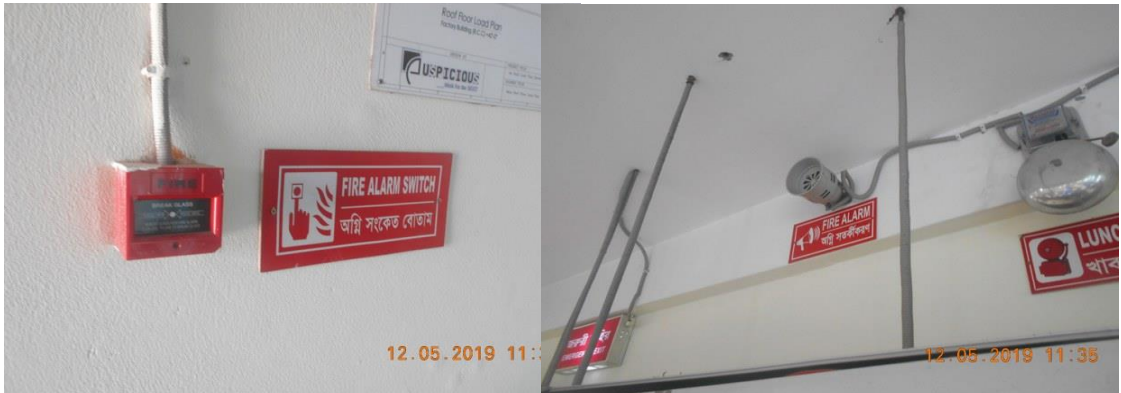
14	Egress Lighting	Inspection, testing, and maintenance for the emergency lighting system was not in accordance with The ACCORD standard.	Inspect, test and maintain the emergency lighting system in the accordance with The ACCORD standard. Keep written records on-site.	Within 1 month
15	Fire Detection and Alarm System	The fire detection and alarm system is antiquated, not a listed system and does not provide alarm and notification features consistent with acceptable standards.	<p>Replace the fire detection and alarm system with a new, listed addressable fire detection & alarm system in accordance with NFPA 72.</p> <p>Design shall be submitted to ACCORD Chief Safety Inspector for review prior to installation of the system.</p>	Design within 4 months and installation within 9 months.
