Shafi Knit Ltd.

Natun Para, Baipail (beside DEPZ-2), Ashulia, Savar, Dhaka
(23.945646N, 90.277794E)

12th May 2019

Structural Inspection Report

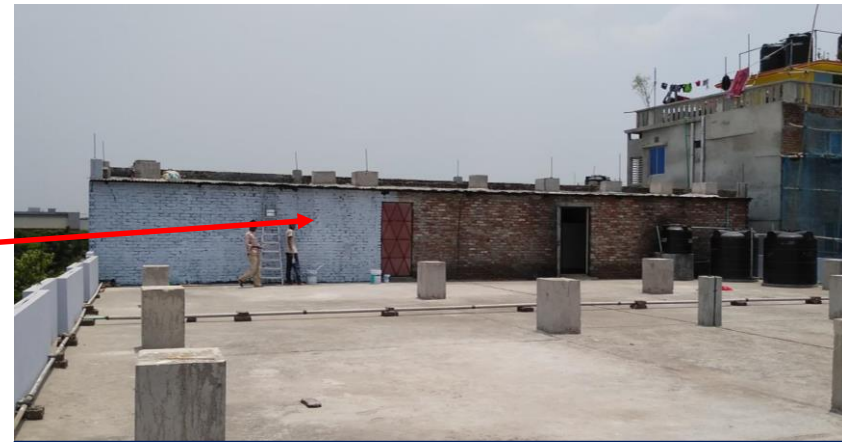
Prayer Shed

Apparent non-engineered shed was found at roof level. Light weight roof structure supported on 125 mm brick wall. The connections appeared to be non-engineered. No documentation was available onsite.

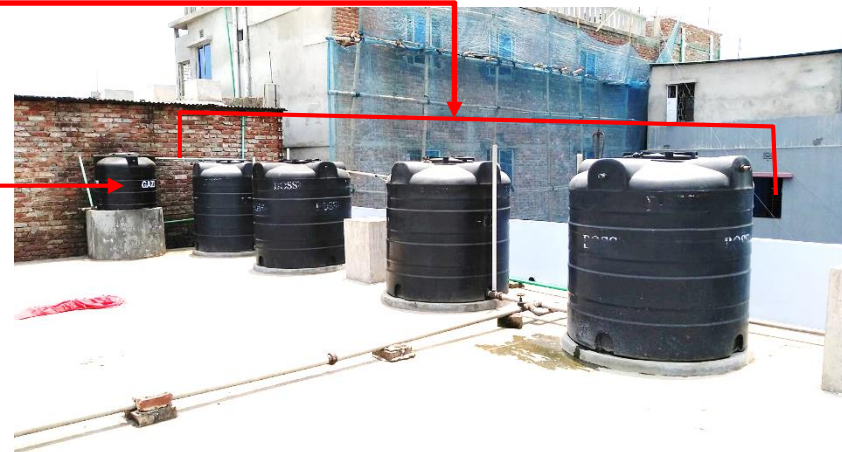
4-2000 liters and 1-500 liters plastic water tanks on roof

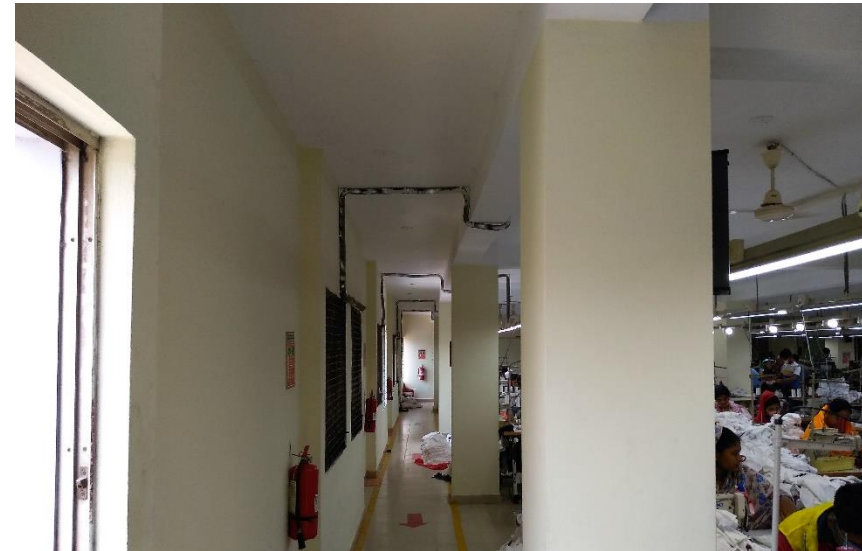
Cantilever Areas

Cantilever beams were found only at 3rd floor roof. A Typical Floor Beam Layout Plan shows cantilever beams. In addition, beam down stand was measured 200 mm instead of 250 mm (as per provided as-built drawing) at 1st to 3rd floor beams.

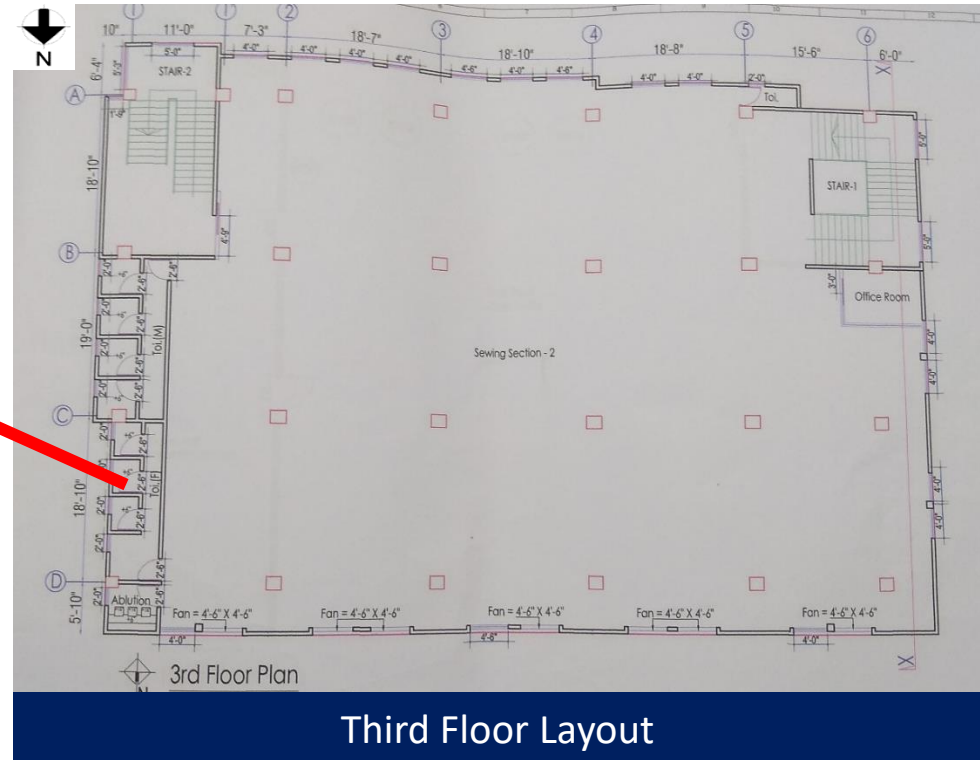
Third Floor Layout

Number of toilets did not match with as-built drawings. Six nos. of female toilets were found on site where as-built drawing shows three nos.

Factory is required to revise the DEA including Load Plan as per actual onsite condition and submit to Accord.

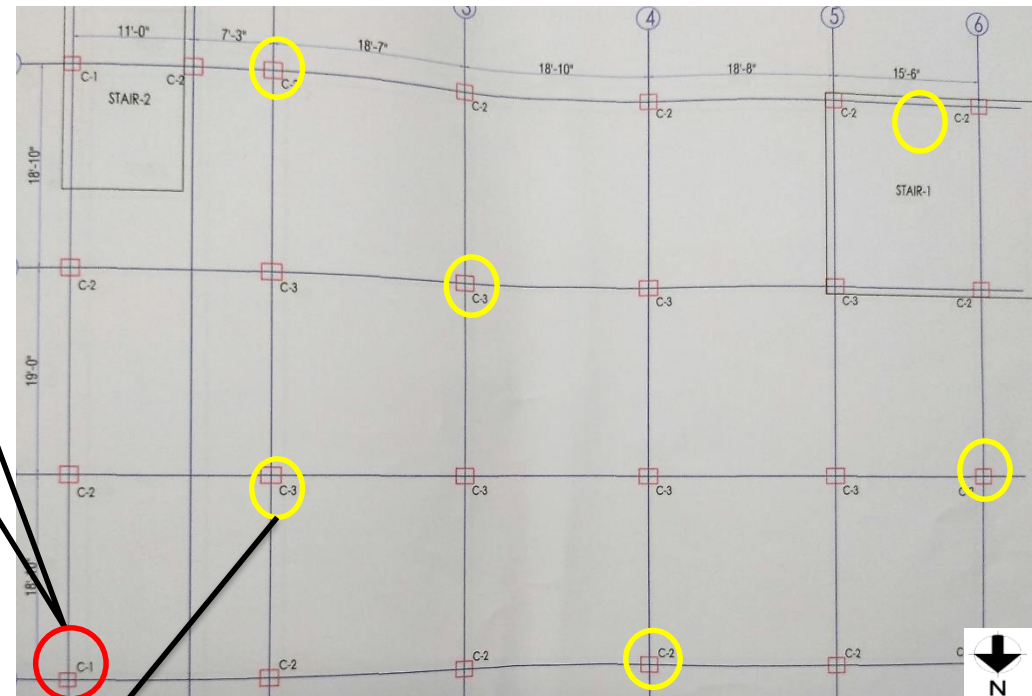
Column layout

Rebar was checked
on site by ferro
scanning of different
types of columns
